Smoke and Dye Testing Summary

High Level Sewershed

Test ID	Test Type	Date Inspected	Company / Super.	Blower MH	Ground Condition	Notification Made?	Total Length
S1028-083	Smoke	9/11/2008	ADS/TM	S11CC1016MH	Dry	Yes	787.63

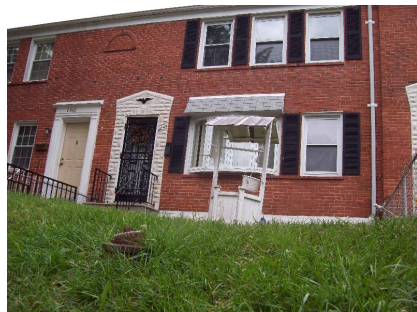
Picture \S1028-083-OB01-P01.jpg

Comments Smoke from cleanout in front yard. 4044 Edgewood Rd.

Comments Front of house, 4044 Edgewood Rd.

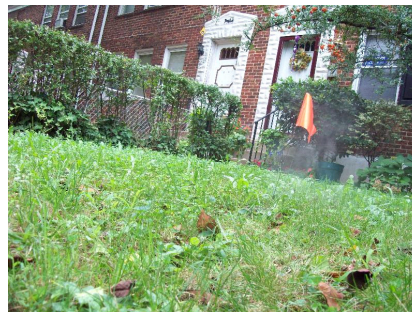
Picture \S1028-083-OB02-P01.jpg

Comments Smoke from cleanout in front yard. 4025 Edgewood Rd.

Comments Front of house, 4025 Edgewood Rd.

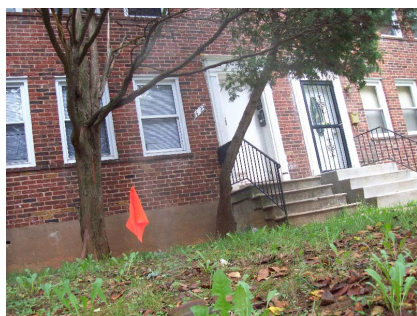
Picture \S1028-083-OB03-P01.jpg

Comments Smoke from cleanout in front yard. 4023 Edgewood Rd.

Comments Front of house, 4023 Edgewood Rd.

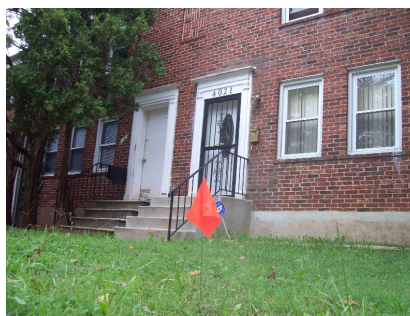
Picture \S1028-083-OB04-P01.jpg

Comments Smoke fom cleanout in front yard. 4021 Edgewood Rd.

Comments Front of house, 4021 Edgewood Rd.

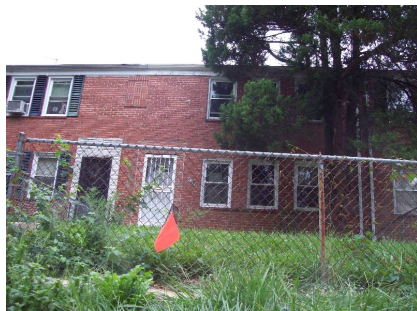
Picture \S1028-083-OB05-P01.jpg

Comments Smoke from service lateral in front yard. 4026 Edgewood Rd.

Comments Front of house, 4026 Edgewood Rd.

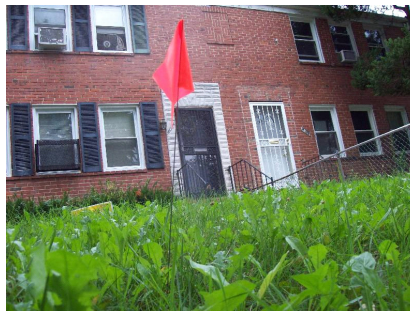
Picture \S1028-083-OB06-P01.jpg

Comments Smoke from cleanout in front yard. 4024 Edgewood Rd.

Comments Front of house, 4024 Edgewood Rd.
